KNOWING JAGUAR’S DAMS

MOITA DAM

TURMALINA DAM

PACIÊNCIA DAM

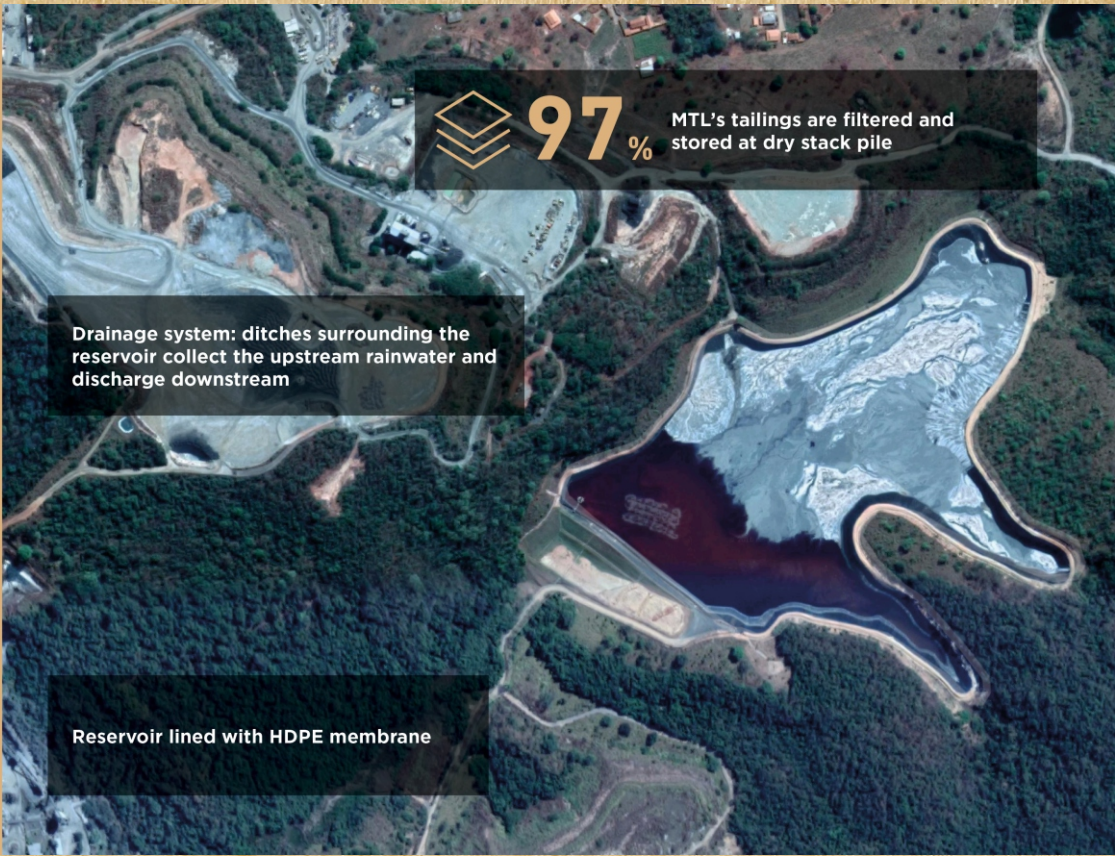
DAM HEIGHT: 17M

CAPACITY: 790.682,7 M³

DAM LENGTH: 198 M

CONSTRUCTIVE METHOD: DOWNSTREAM, NO RAISE

MTL's tailings are filtered and stored at dry stack pile

Drainage system: ditches surrounding the reservoir collect the upstream rainwater and discharge downstream

Reservoir lined with HDPE membrane
